WANTASTIQUET LAKE  
VT00073

PHASE I INSPECTION REPORT  
NATIONAL DAM INSPECTION PROGRAM

DEPARTMENT OF THE ARMY  
NEW ENGLAND DIVISION, CORPS OF ENGINEERS  
WALTHAM, MASS. 02154

AUGUST 1978

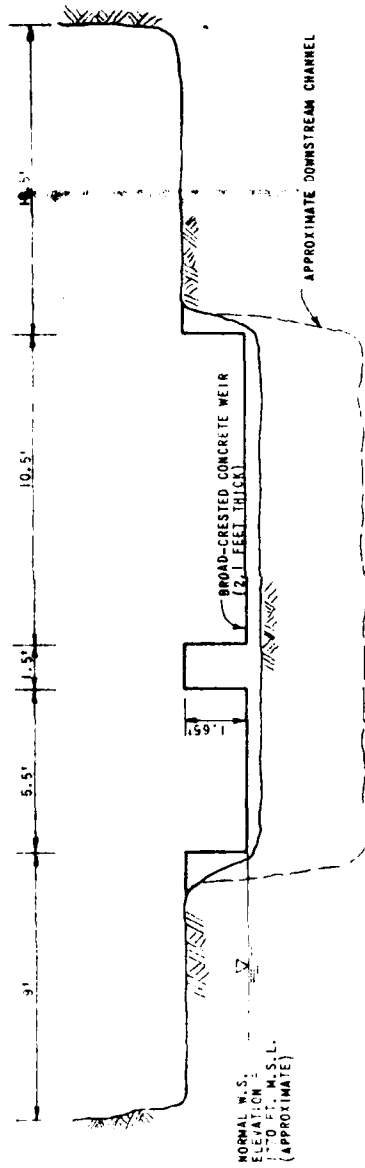
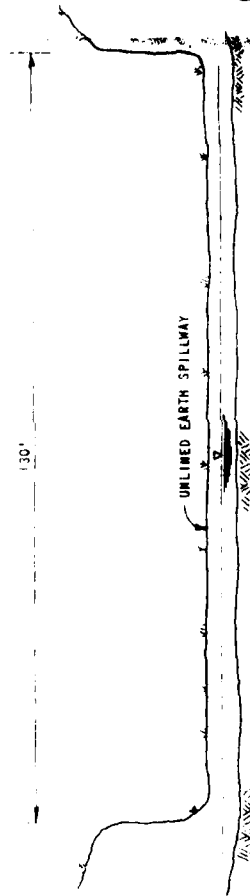
FIGURE 5

Spillway No. 2 (Figure 7 in Appendix B) is actually an earthen dike constructed in a saddle in the natural ground, to prevent fish from entering and leaving the lake. Under normal conditions, the spillway crest is above the water surface. Under flood conditions the dike would be overtopped, and possibly destroyed. The failure of the dike would not do any damage because of the fact it is so small, and located in a natural channel. See Figure 5 Appendix B.

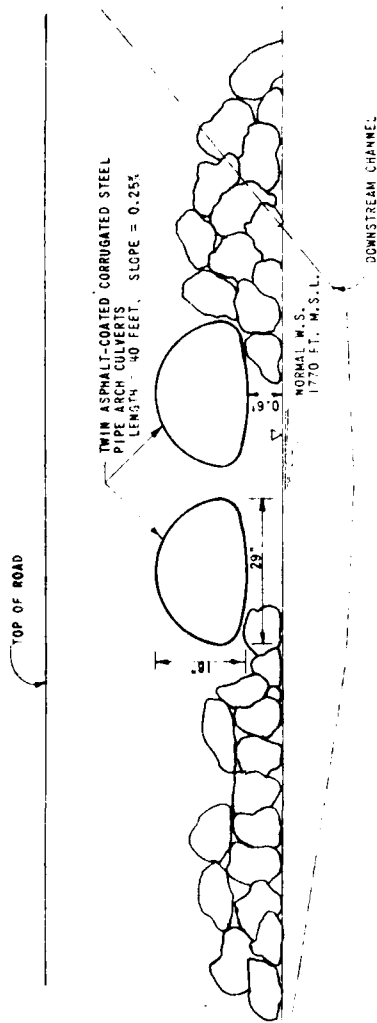
FIGURE 6

Spillway No. 3 (refer to Figures 6 and 7 in Appendix B) is a pipe overflow spillway consisting of two asphalt-coated corrugated metal pipe arch culverts. The culverts are located off the western end of the dam embankment and pass under Trout Club Road. This spillway was recently reconstructed and is in good condition.

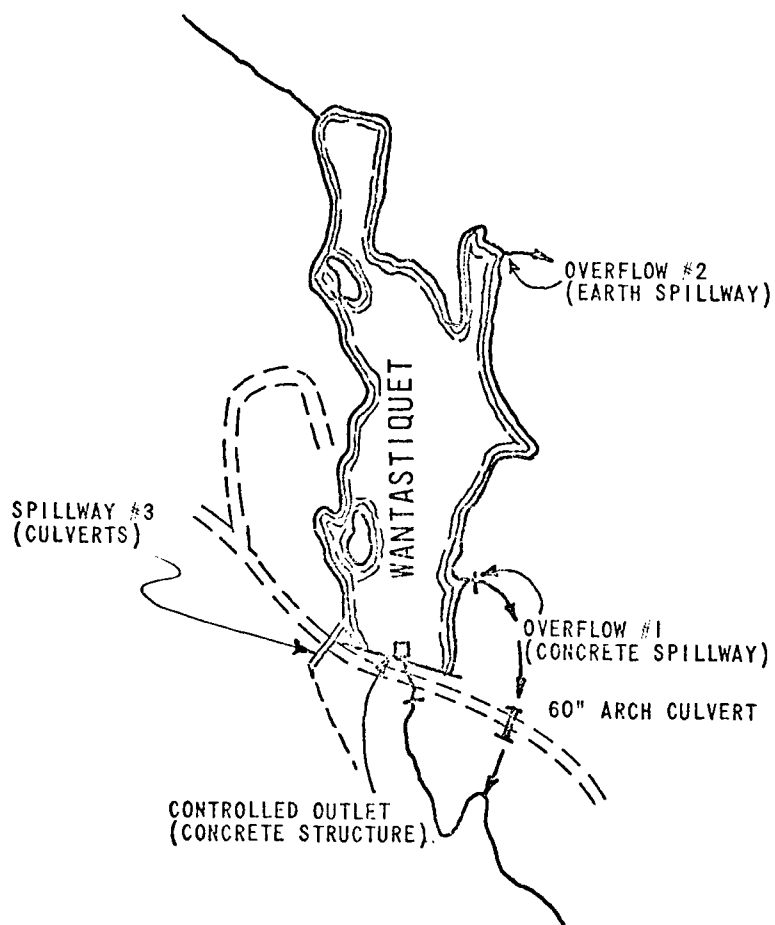
FIGURE 7

The primary spillway (referred to as spillway No. 1 on Figure 7 in Appendix B) is a broad crested weir constructed of reinforced concrete. The spillway is divided into two parts by a concrete pier. On the crest of the spillway is a wooden fish rack approximately 30-inches high (refer to photographs 7 and 8). The spillway is in good condition with only minor deterioration of the concrete observed. There is a relatively large crack in the concrete near the right side of the wier. This spillway appears to be built on natural ground in a pre-existing lake outlet.

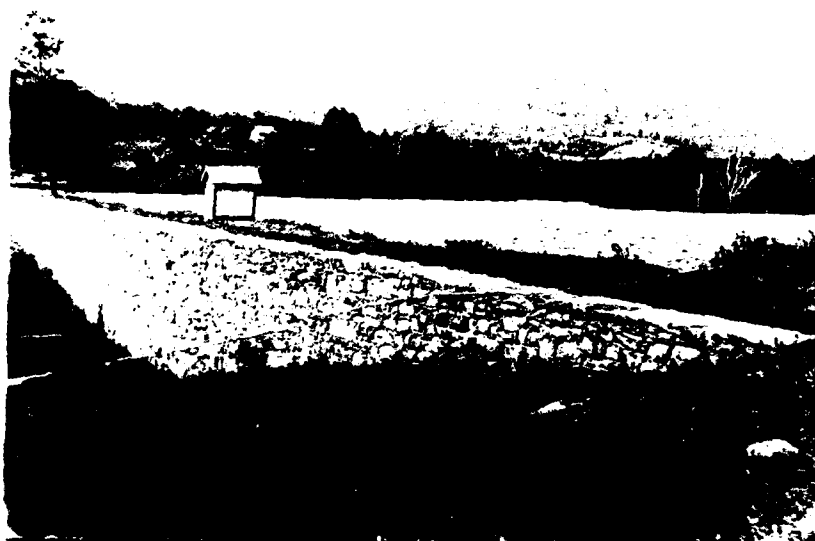
1  
EARLY 1900'S PHOTOGRAPH FROM LEFT ABUTMENT SHOWING  
ORIGINAL CONSTRUCTION

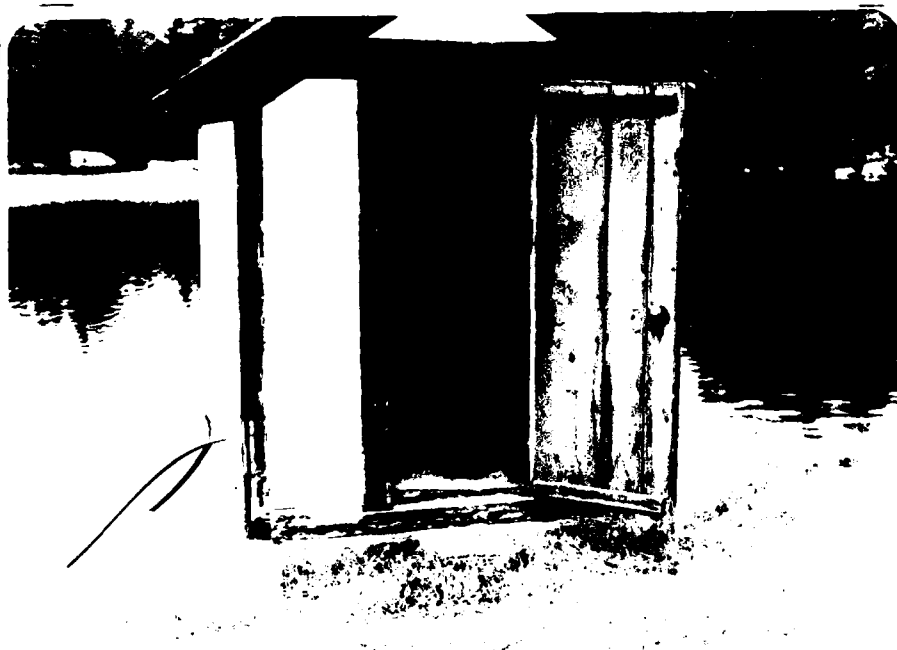
3 GATE HOUSE WITH OPERATING MECHANISM

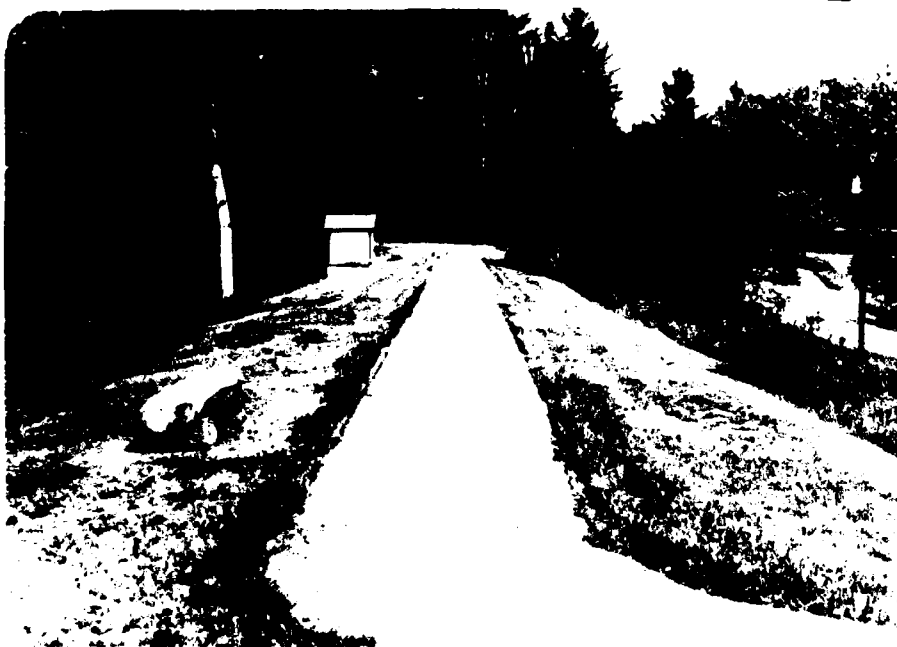
4 VIEW OF DAM CREST LOOKING TOWARD THE LEFT ABUTMENT

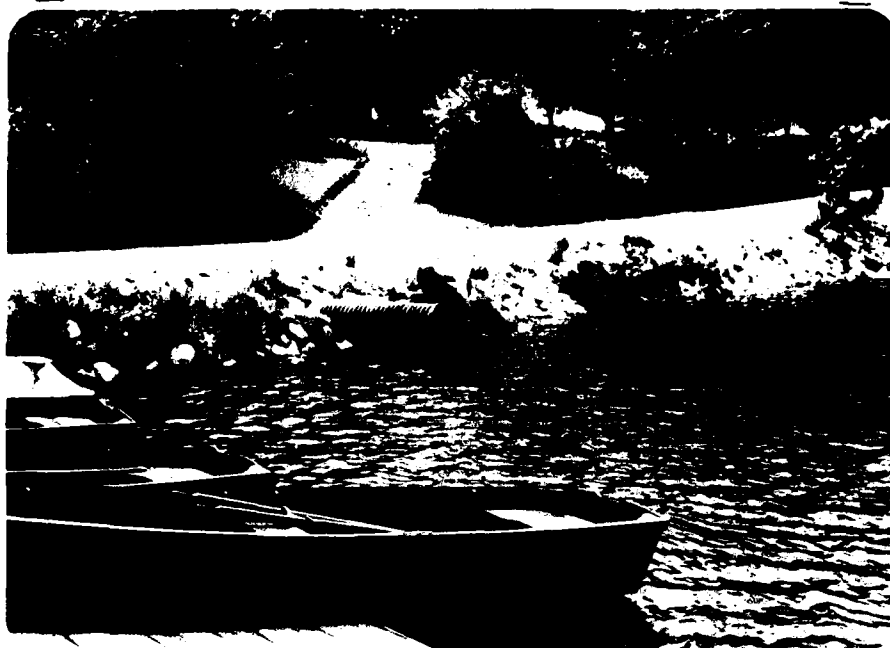
5 INTAKE FOR SPILLWAY NO. 3 LOCATED NEAR RIGHT DAM ABUTMENT
